March 7, 2017

Site: Puget Sound Emergency Radio Network
Education Hill
10365 172 Ave NE
Redmond, WA 98052

Re: RFI from City of Redmond: changes are highlighted in yellow

Thank you for requesting my services. I was hired to perform a Visual Risk Assessment (VRA) for the significant* trees growing on the site above and to prepare a "Tree Retention Plan" (subject to Redmond Zoning Code 21.72.060.A.1) to be included in the permit submittal for a proposed site development.

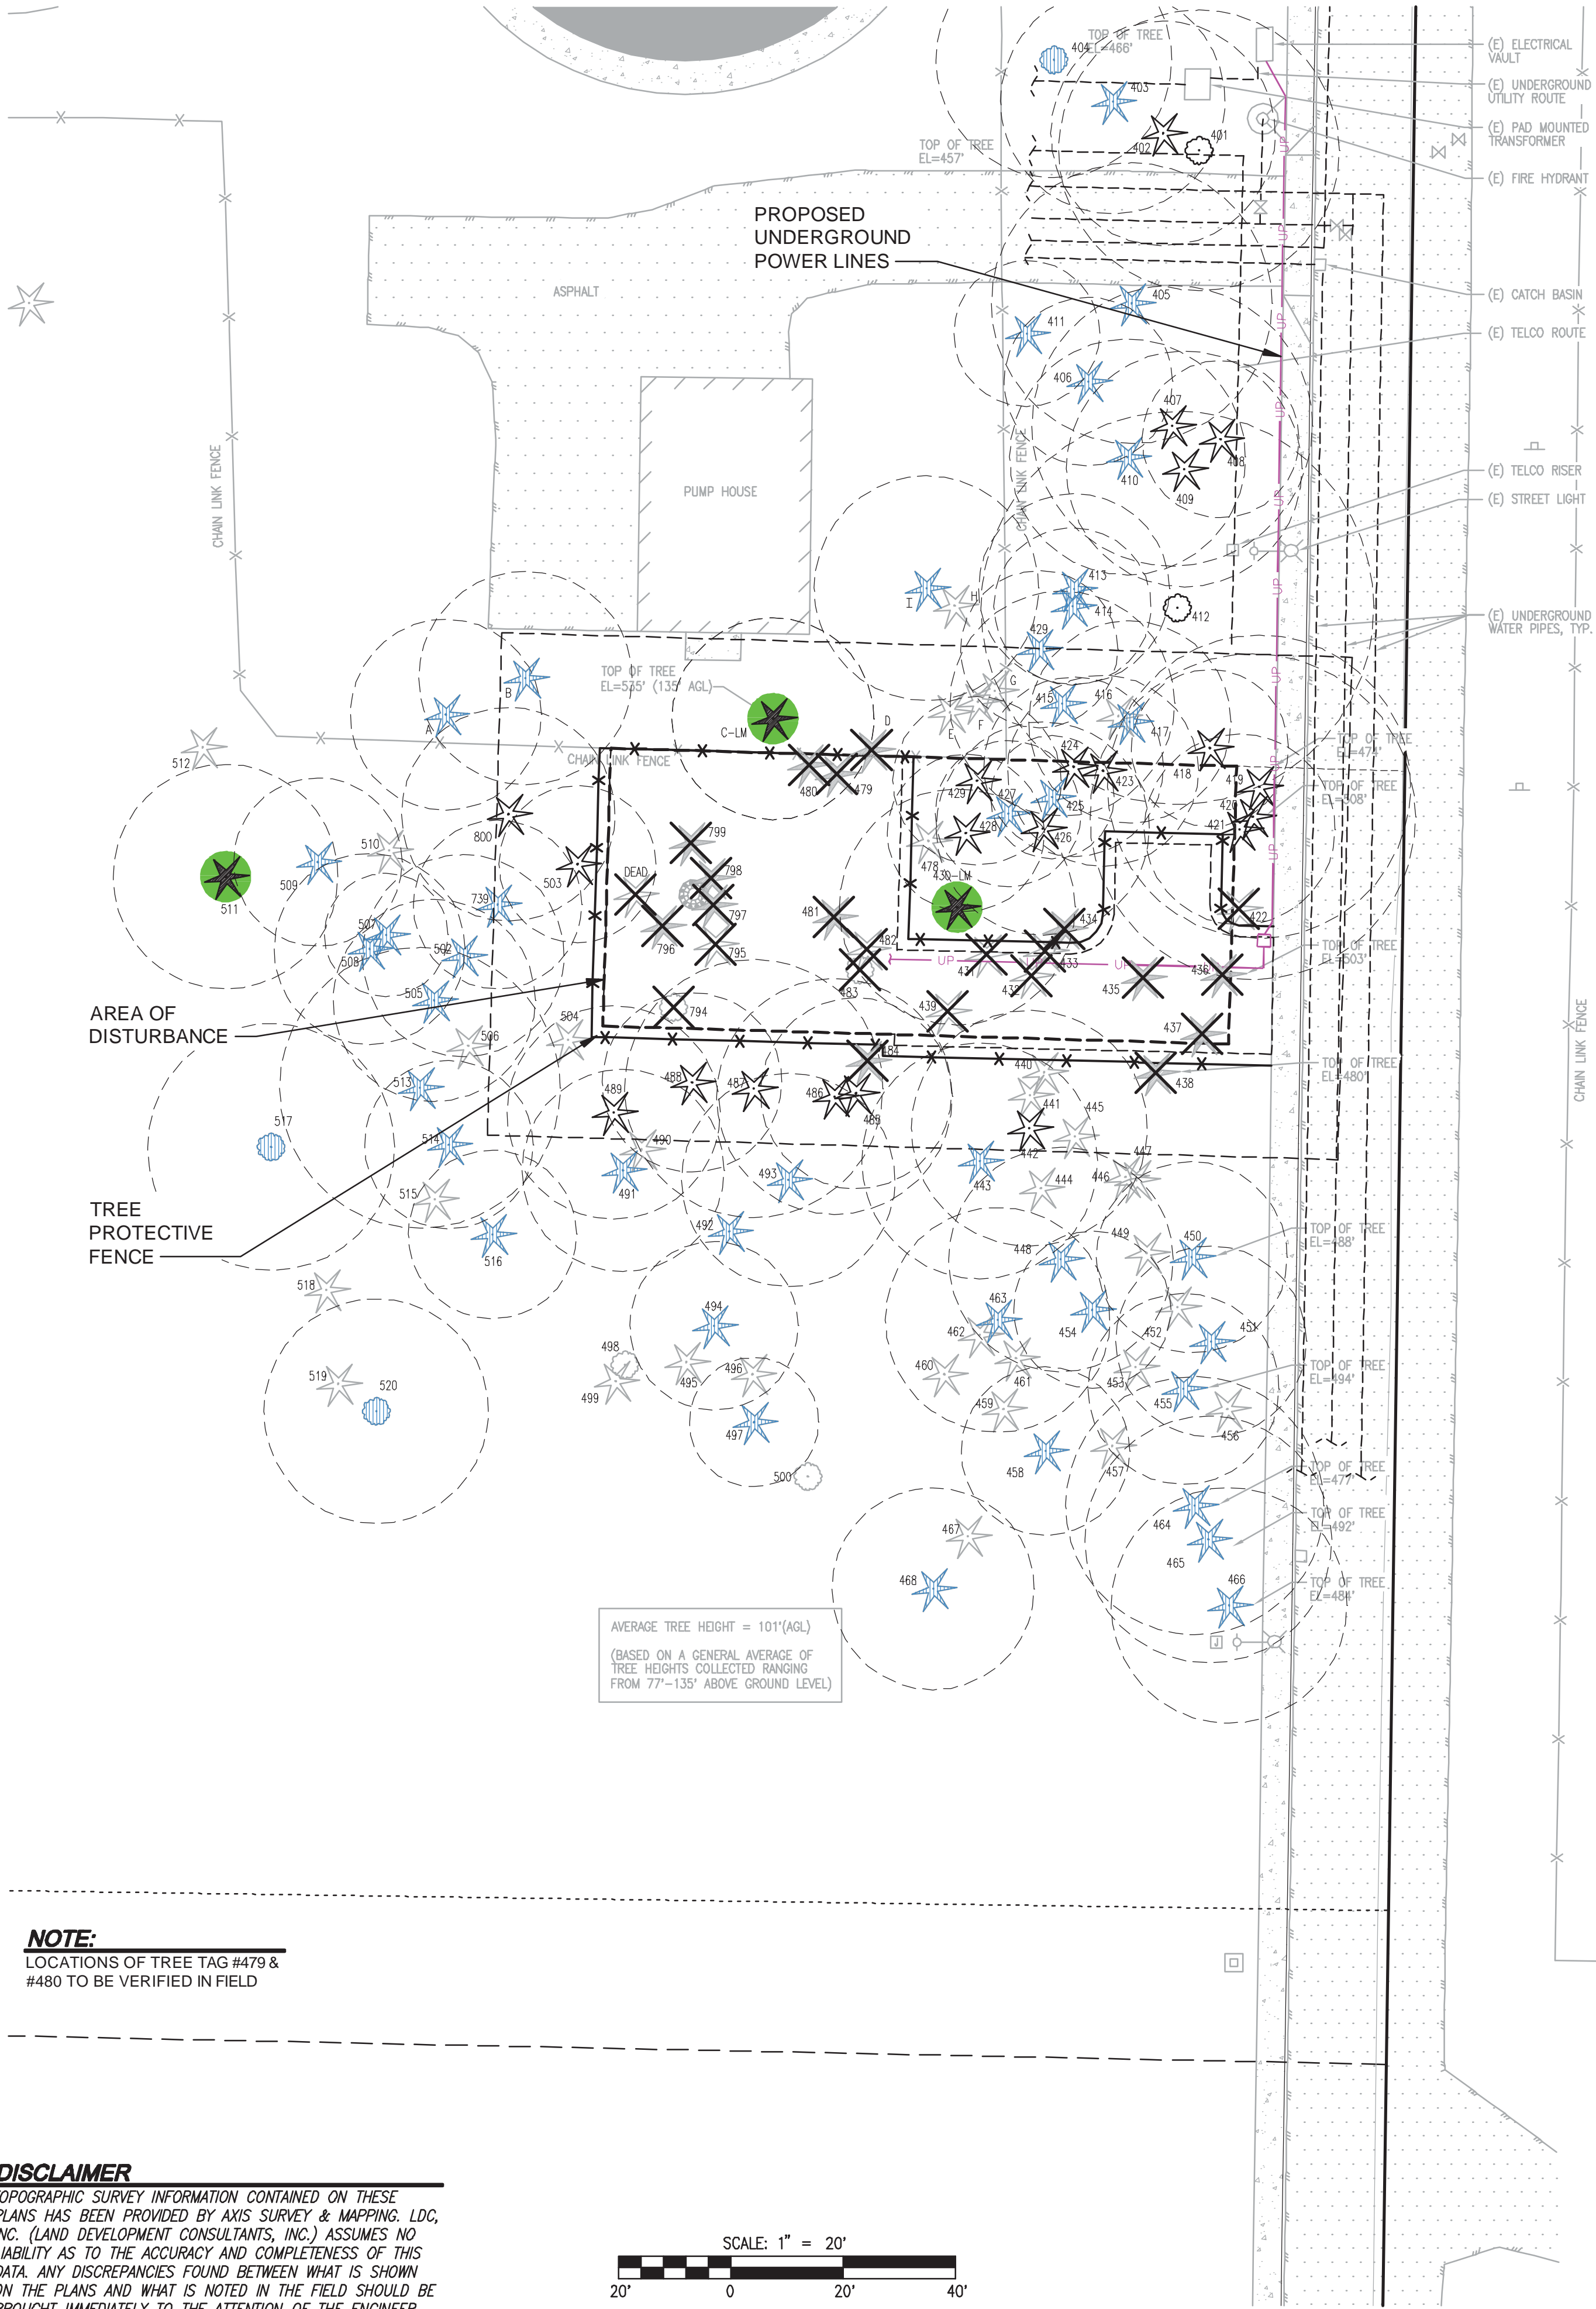
Drawing: E:\2016\Telecom\16-708 Odellia - PSERN Education Hill\Drawings\Construction\16708CD-TP-01.dwg Plotted: Mar 05, 2017 - 1:49pm

NOTE:
LOCATIONS OF TREE TAG #479 & #480 TO BE VERIFIED IN FIELD
